Satellite-Based Damage Assessment for Town of Pauktaw, Pauktaw Township

Assessment based on satellite imagery recorded on morning of 8 November 2012

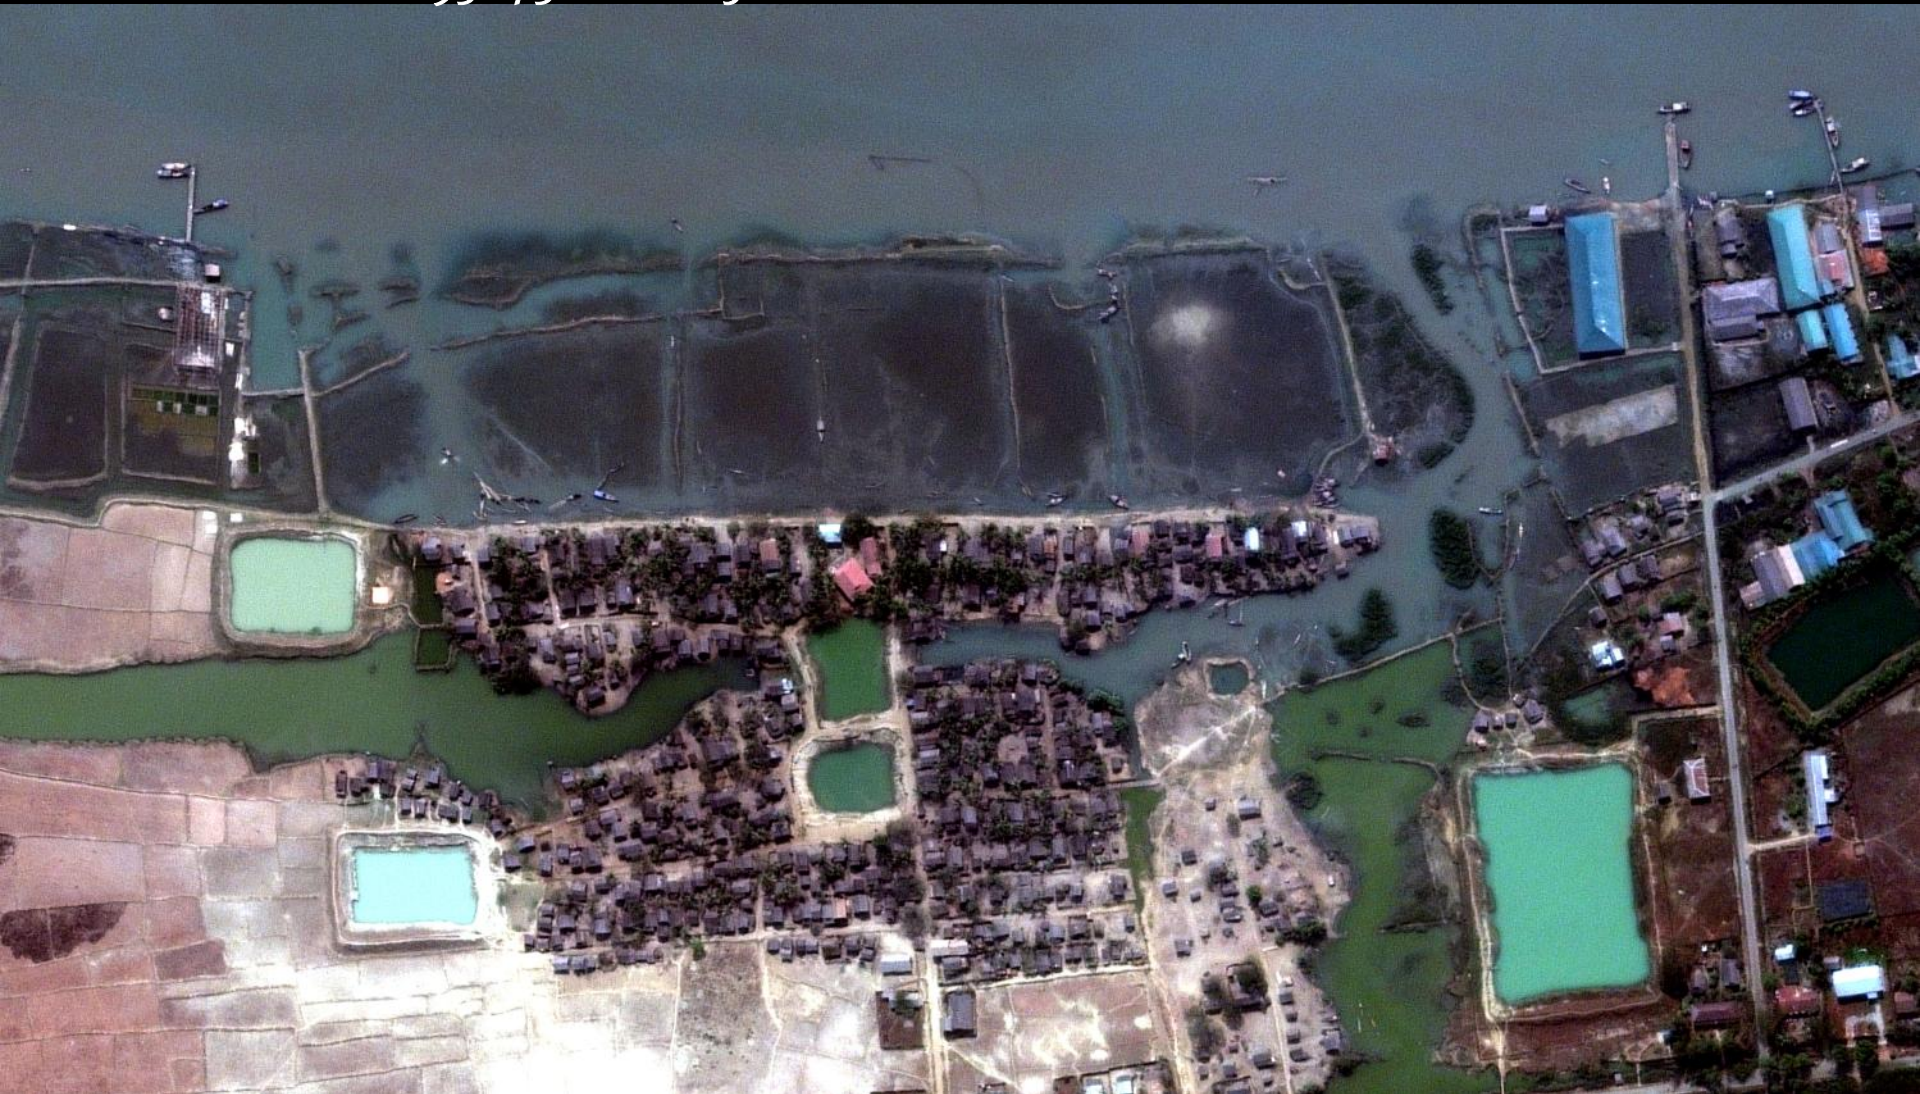
Pauktaw, Pauktaw Township, on 8 November 2012

Post-attack focus on the first zone of building destruction without annotated building damages

First zone of destruction
measuring 5.8ha in area:
total of 294 buildings
destroyed

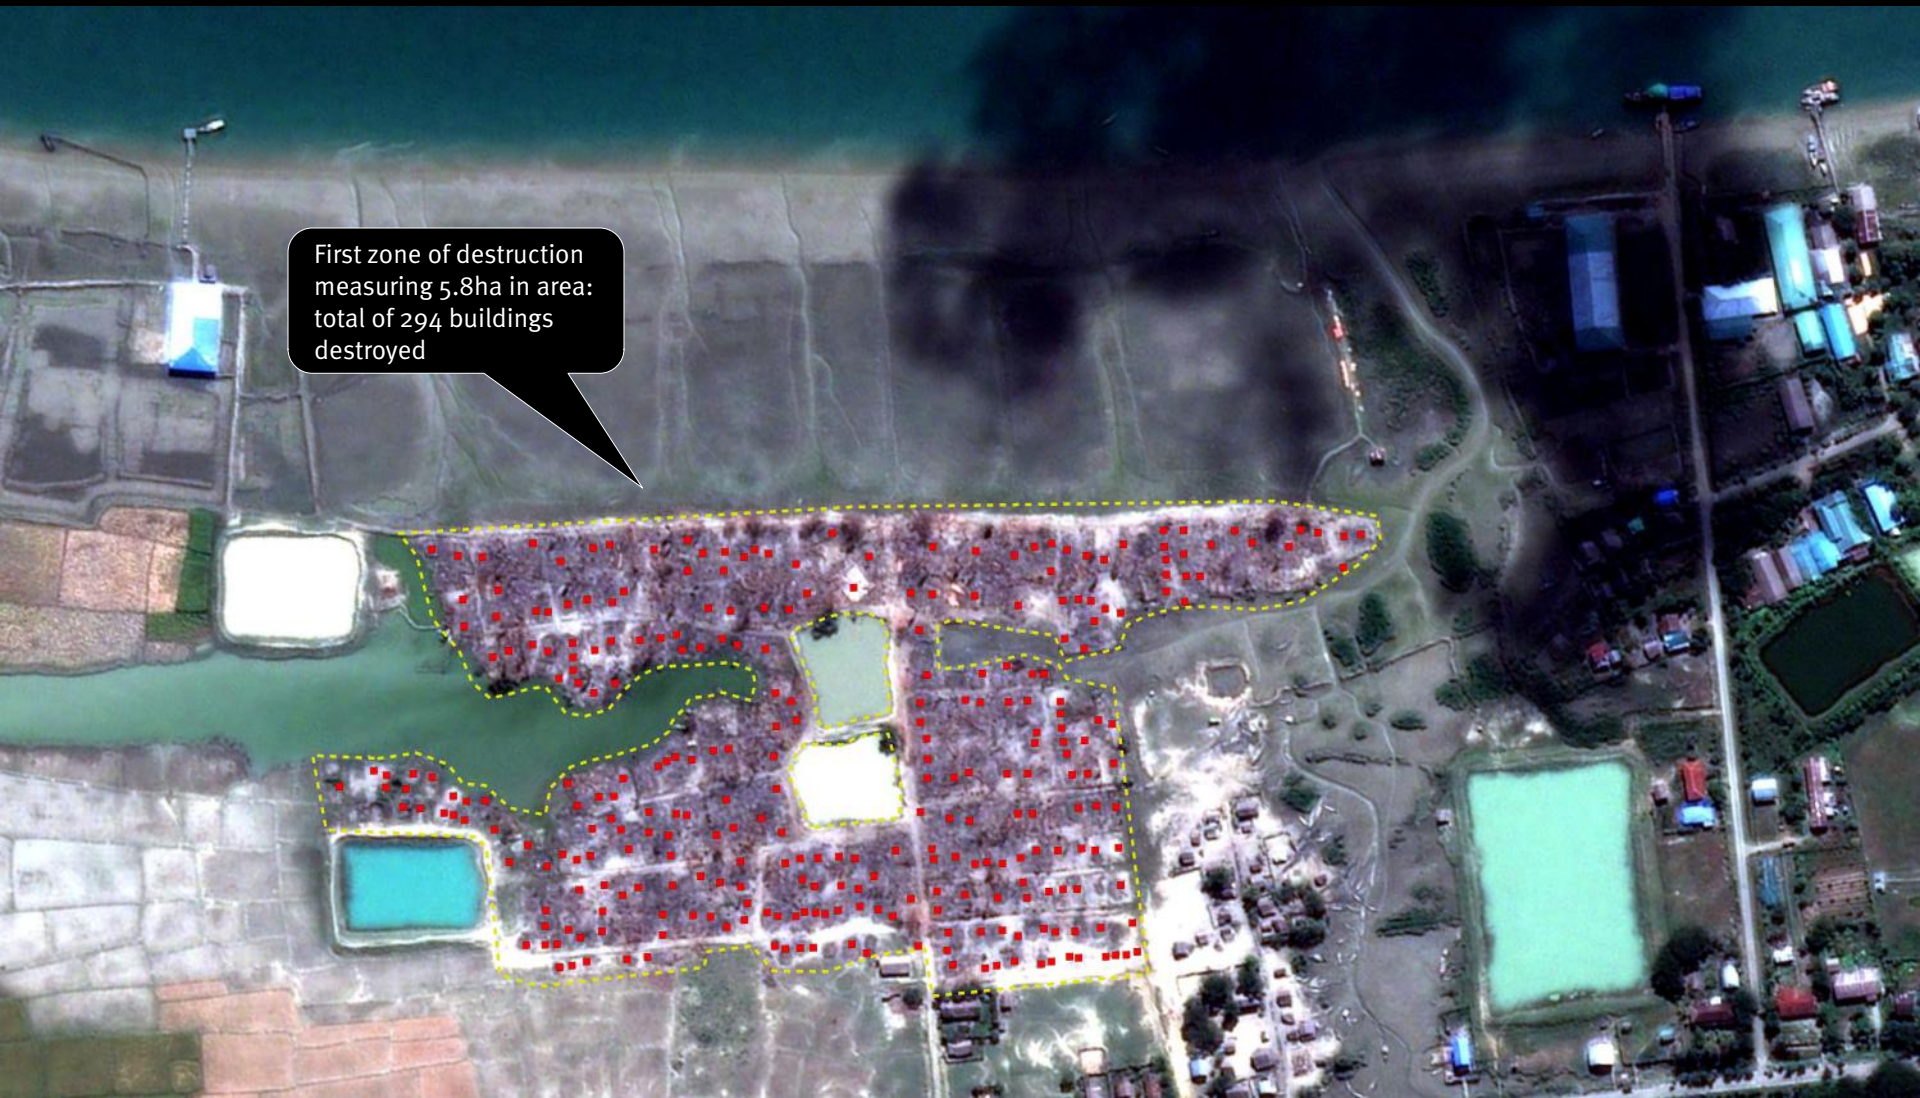
Pauktaw, Pauktaw Township, on 8 November 2012

Post-attack focus on the first zone of building destruction with annotated building damages

First zone of destruction
measuring 5.8ha in area:
total of 294 buildings
destroyed

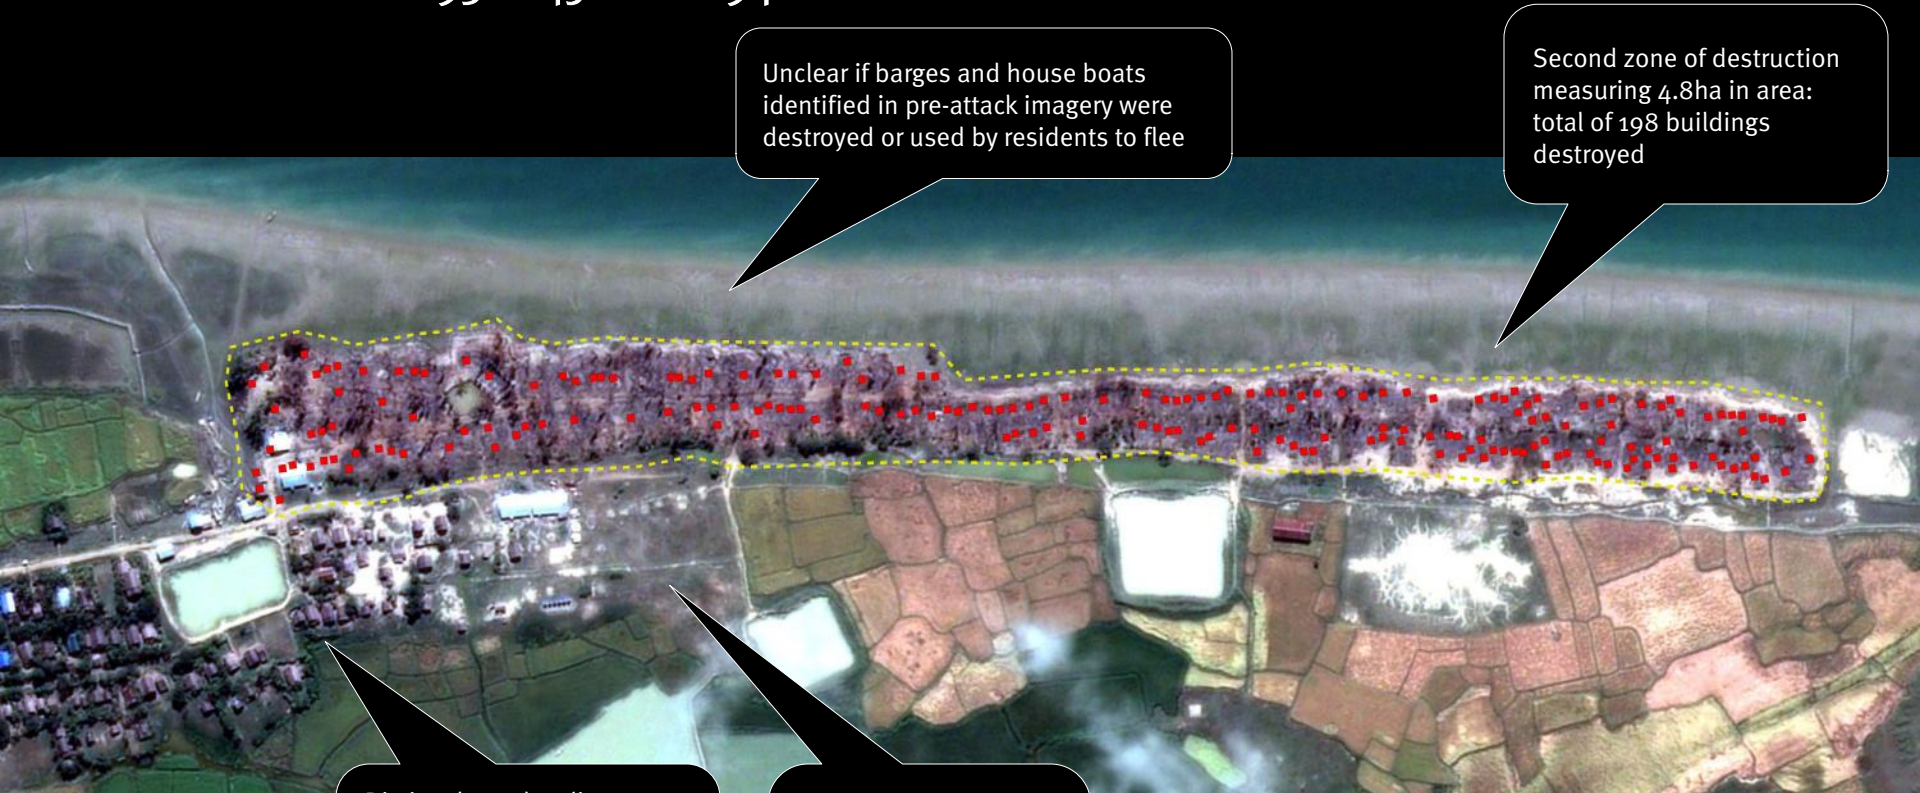
Pauktaw, Pauktaw Township on 8 November 2012

Post-attack focus on the second zone of building destruction with annotated building damages

Unclear if barges and house boats identified in pre-attack imagery were destroyed or used by residents to flee

Second zone of destruction measuring 4.8ha in area: total of 198 buildings destroyed

Distinct boundary line between destroyed and probably undamaged buildings immediately adjacent to the north

Unclear if this small cluster of buildings identified in the pre-attack imagery were destroyed or removed in unrelated context
