HUMAN
RIGHTS
WATCH

Satellite-Based Damage Assessment for City of Meiktila, Mandalay Region, Burma

(Assessment based on satellite imagery recorded on the morning of March 26, 2013)

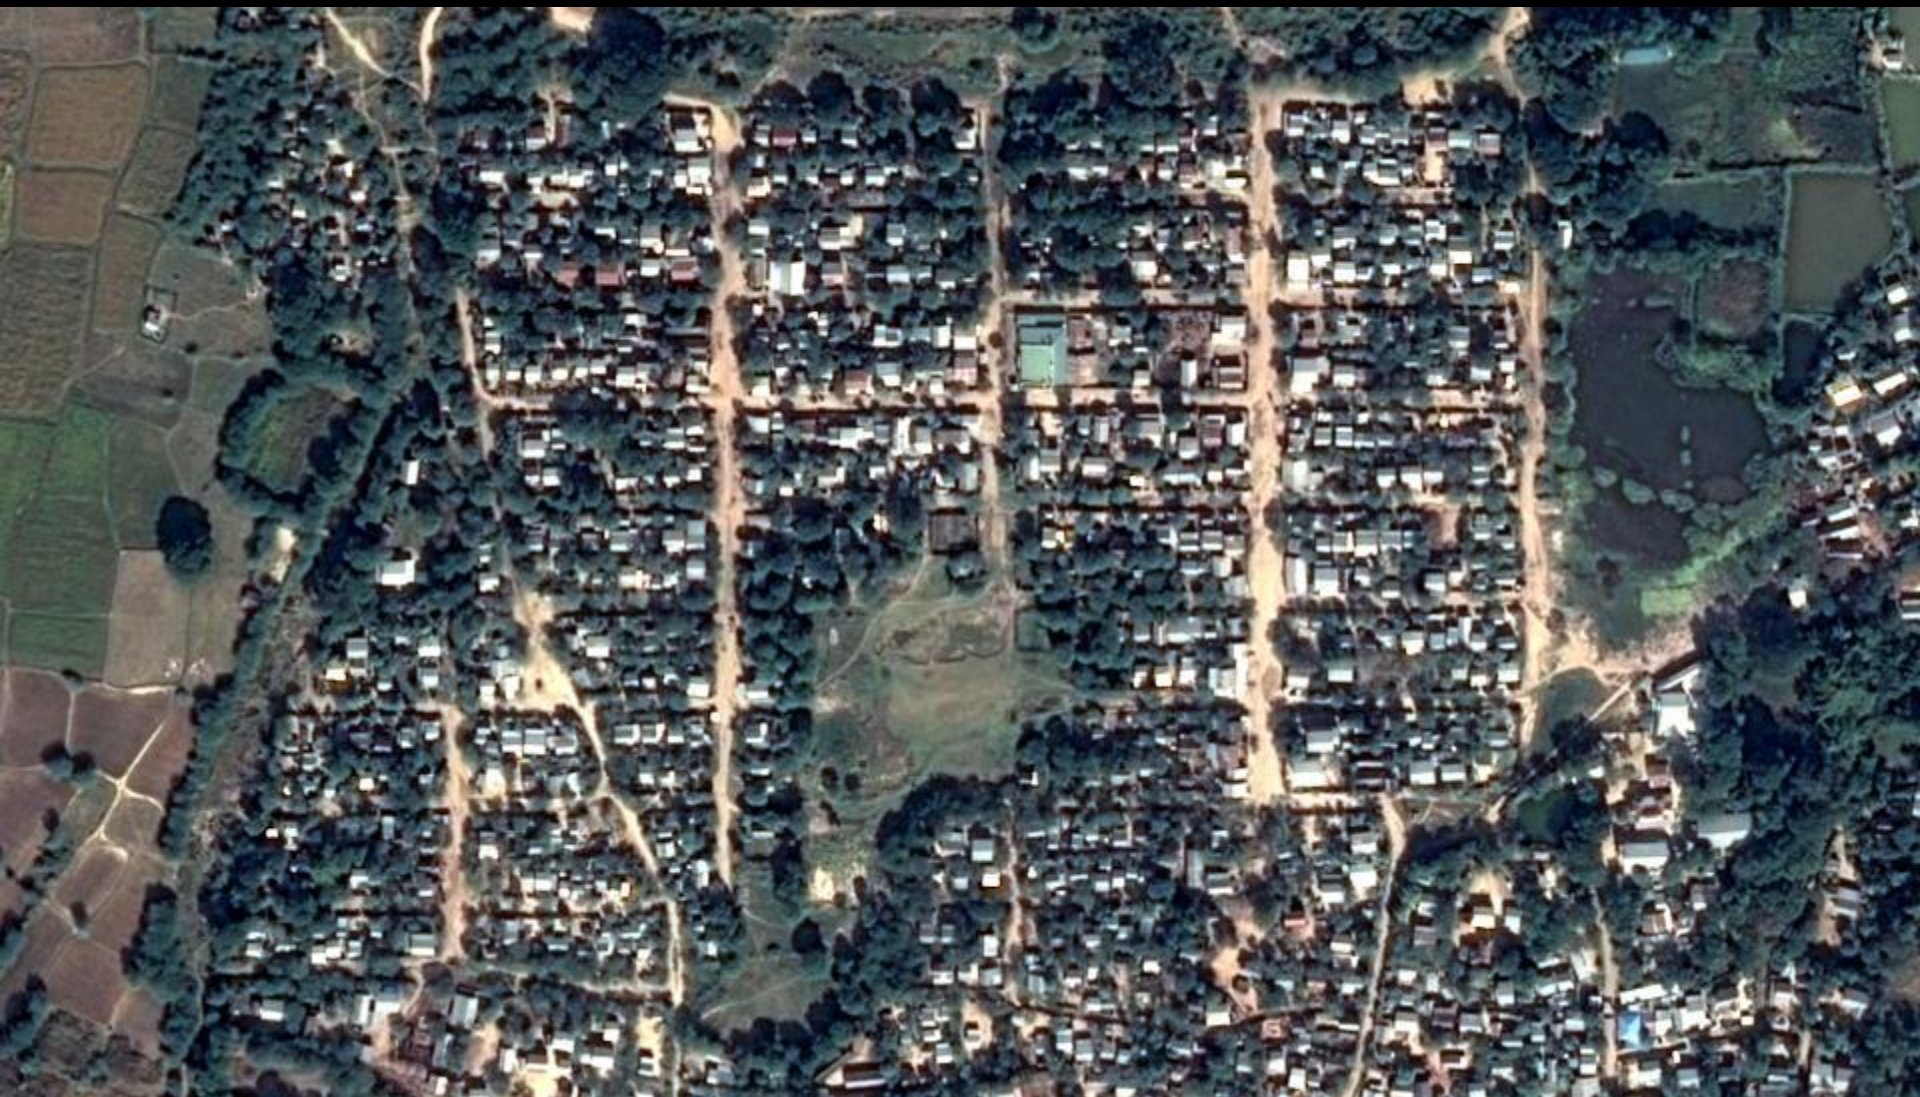
Meiktila (Main Damage Area 1) as on December 13, 2012

(Pre-violence view of largest concentration of building damages)

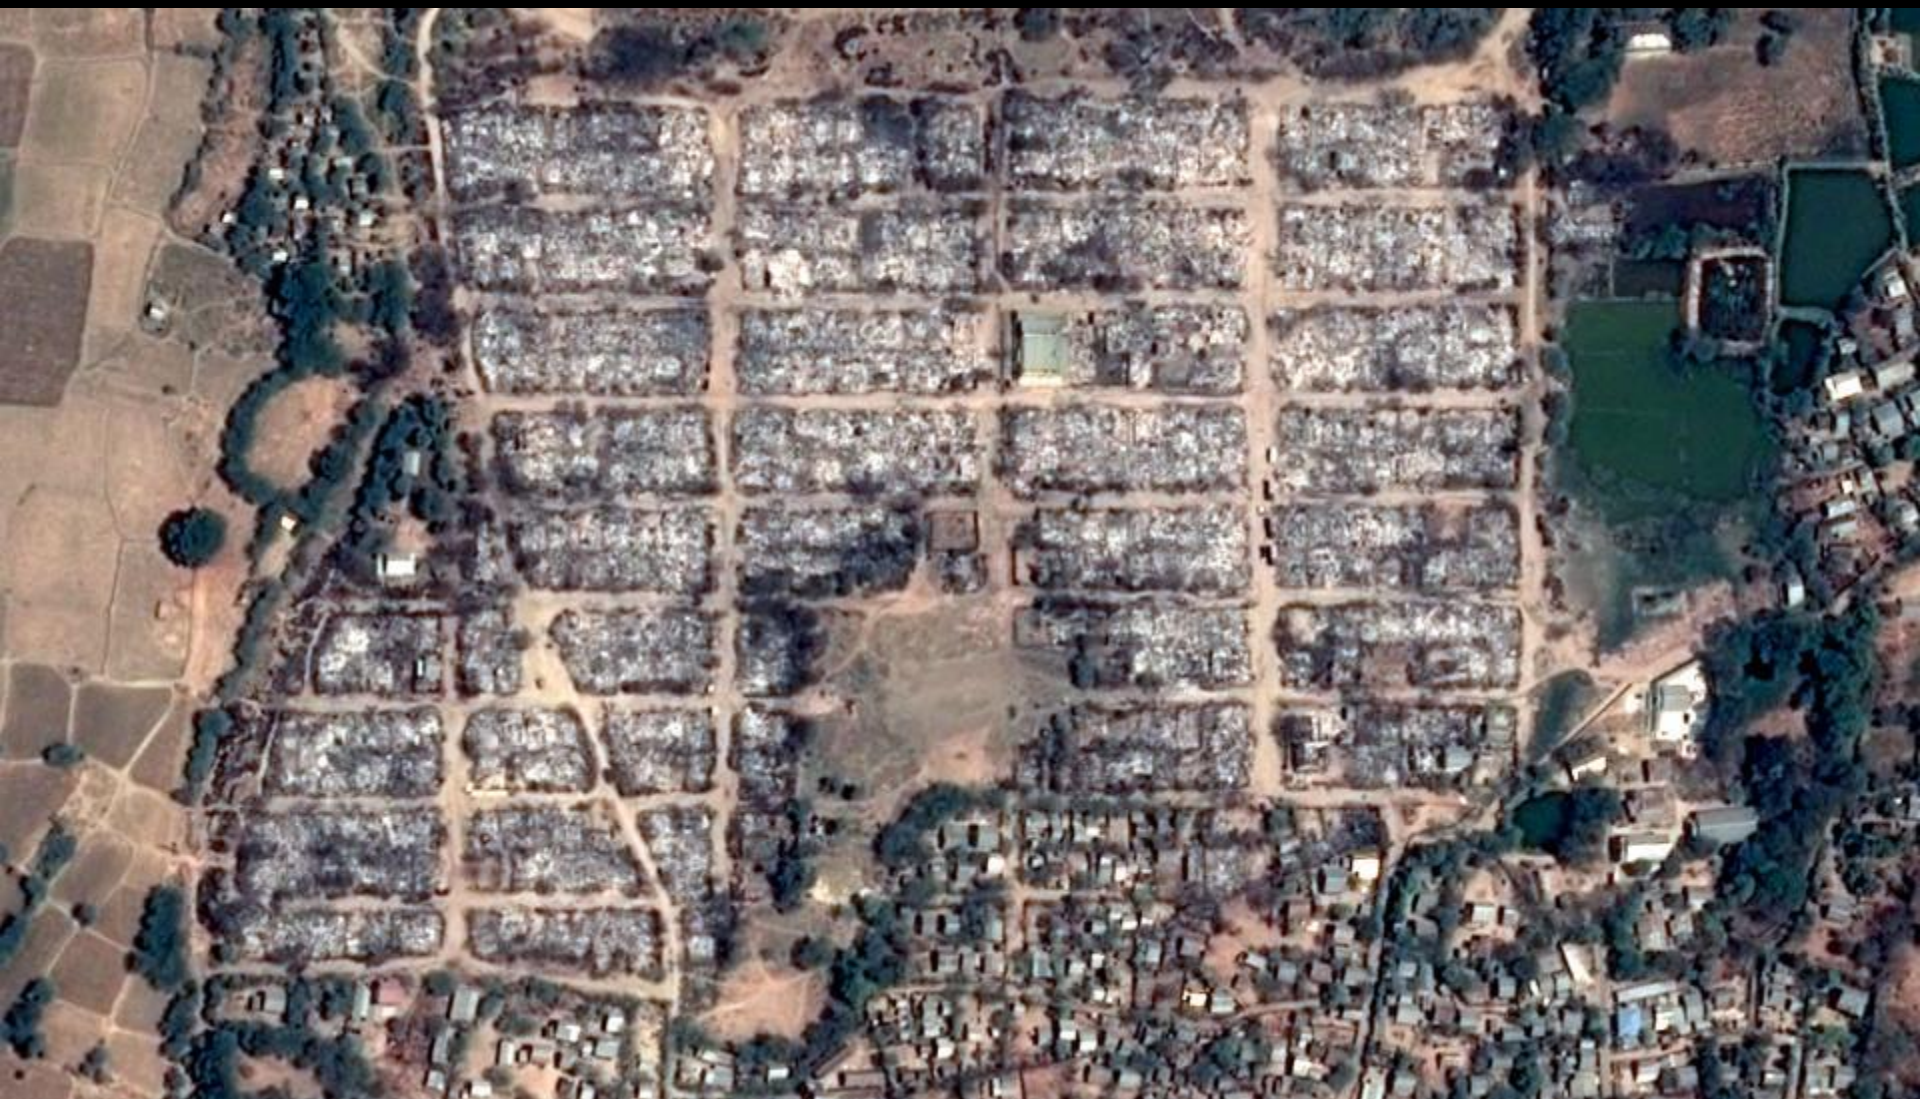
Meiktila (Main Damage Area 1) as on March 26, 2013

(Post-violence view of largest concentration of building damages)

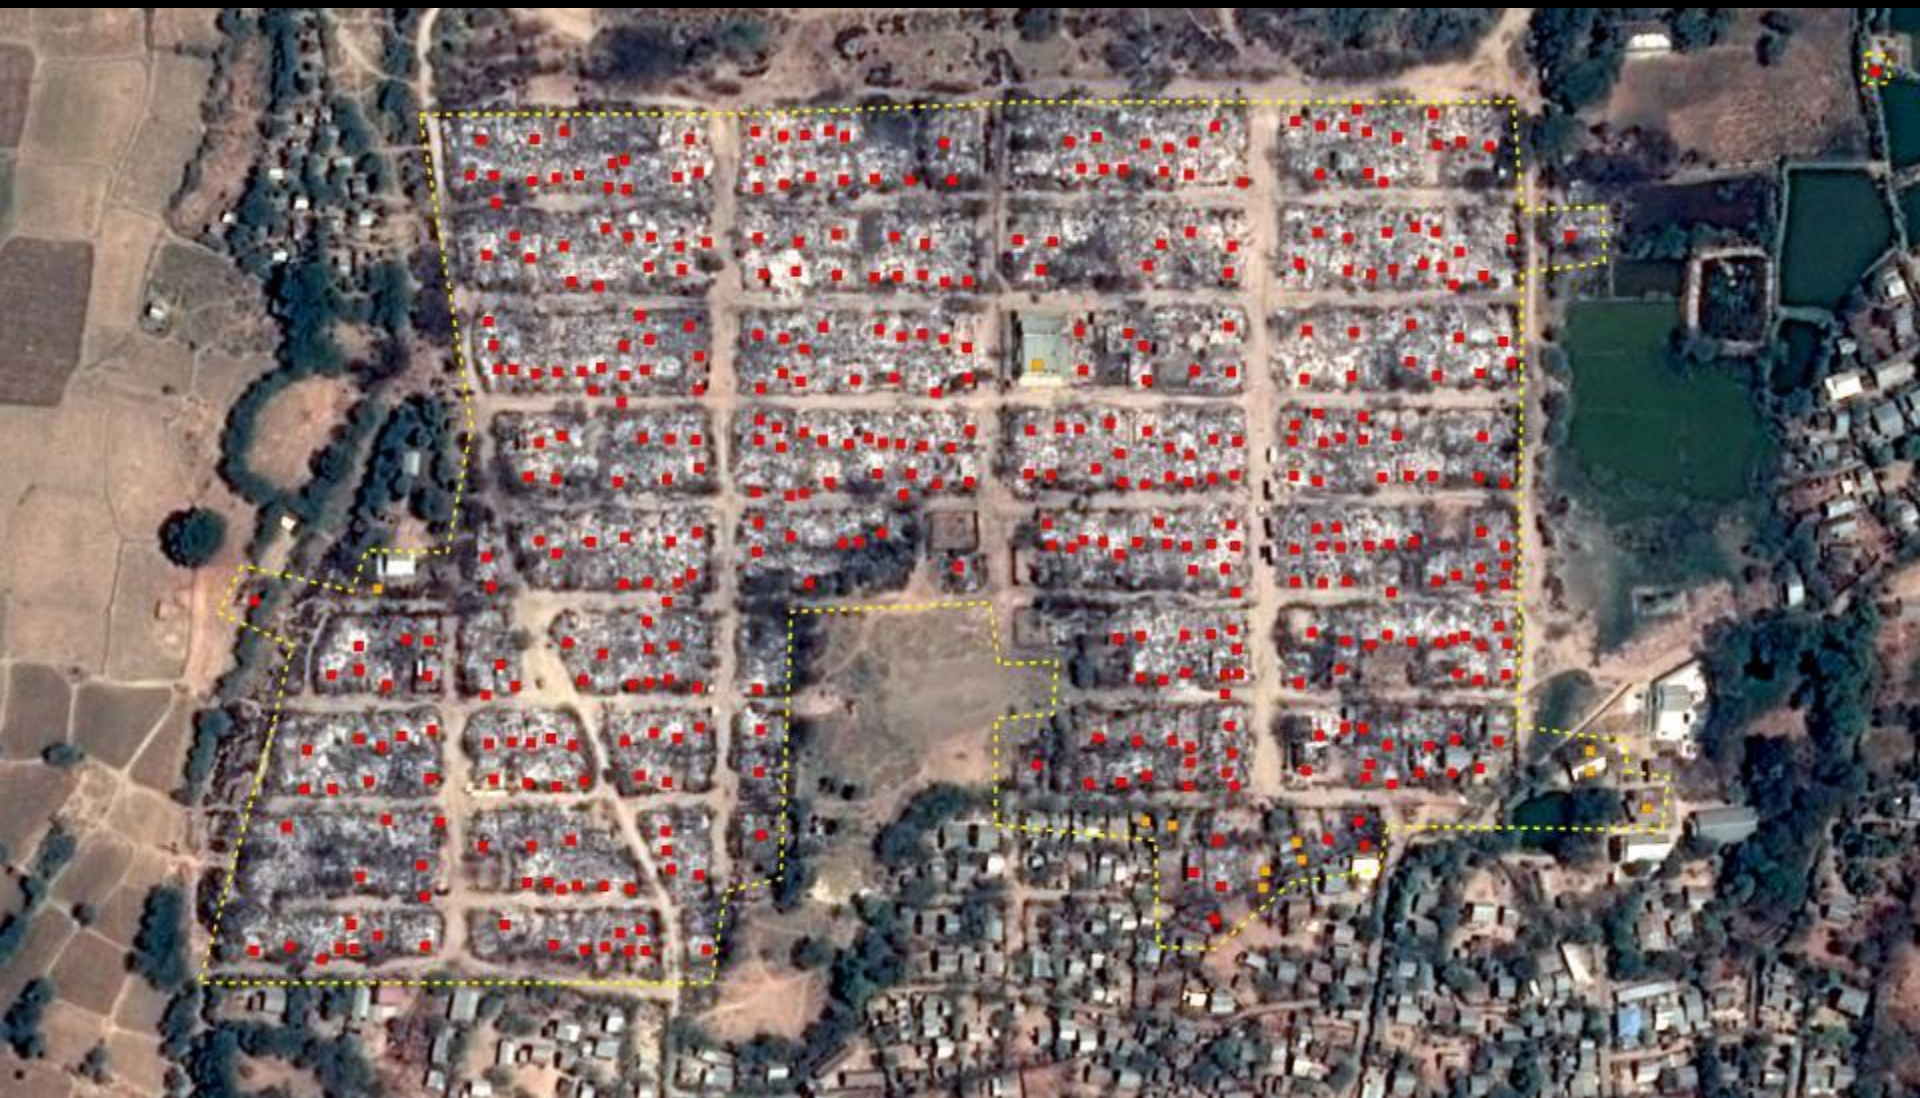
Meiktila (Main Damage Area 1) as on March 26, 2013

(Post-violence view of largest concentration of building damages– Damaged Buildings Annotated)

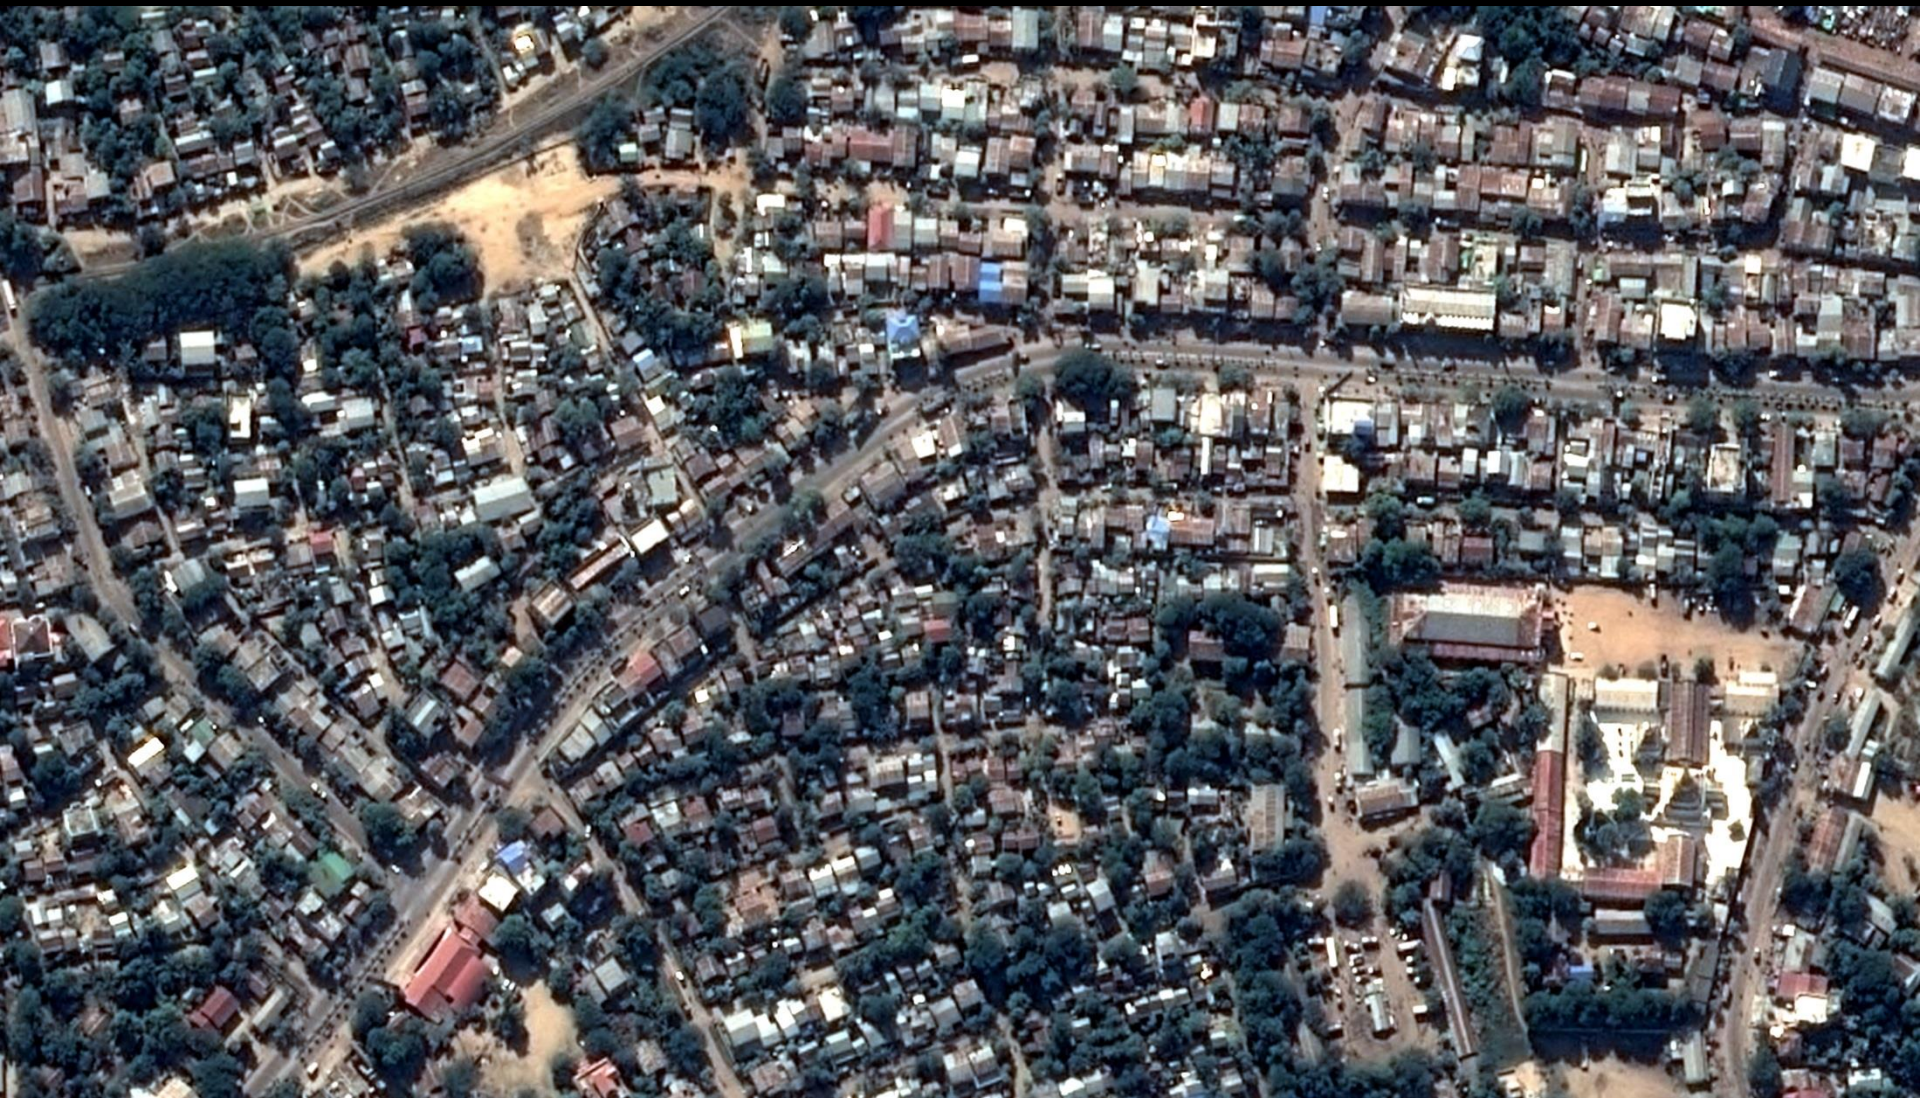
Meiktila (Main Damage Area 2) as on December 13, 2012

(Pre-violence view of second largest concentration of building damages)

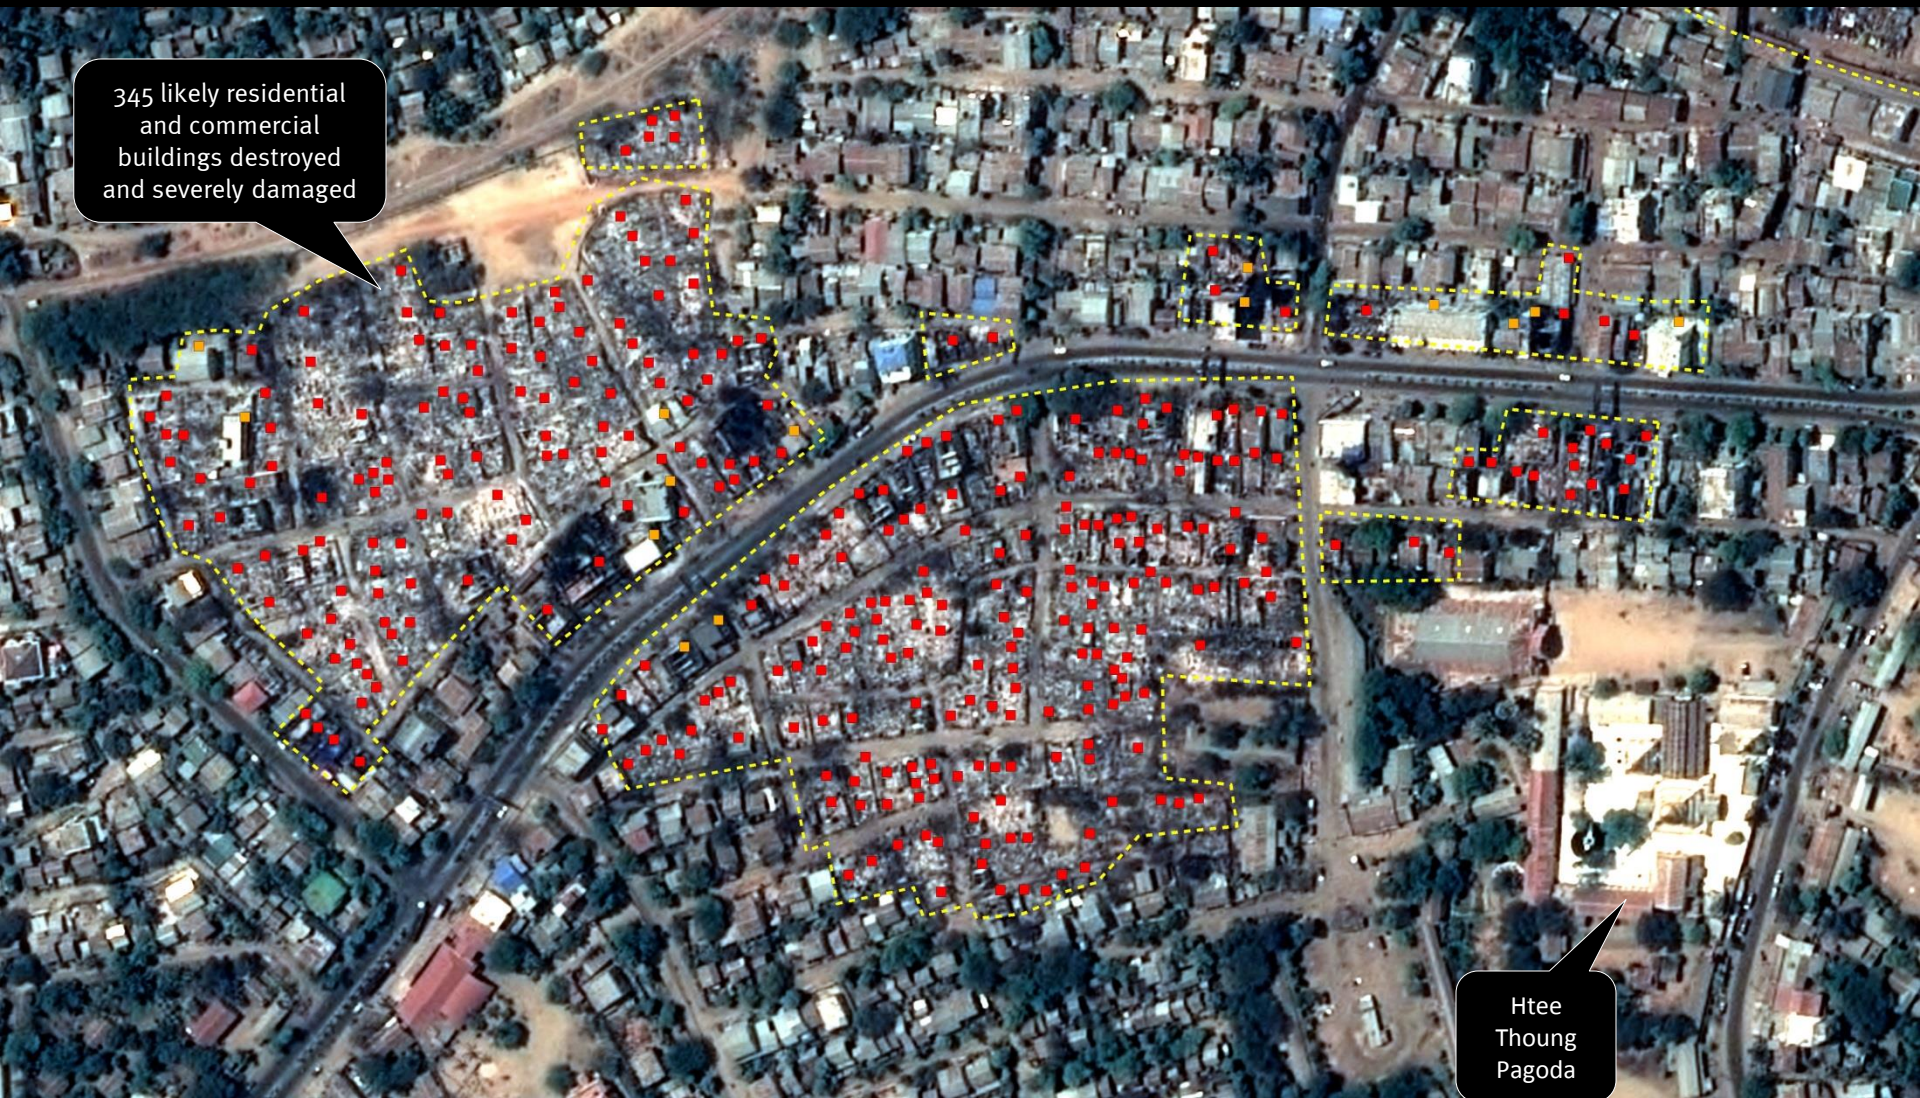
Meiktila (Main Damage Area 2) as on March 26, 2013

(Post-violence view of second largest concentration of building damages— Damages Annotated)

345 likely residential and commercial buildings destroyed and severely damaged

Htee Thoung Pagoda

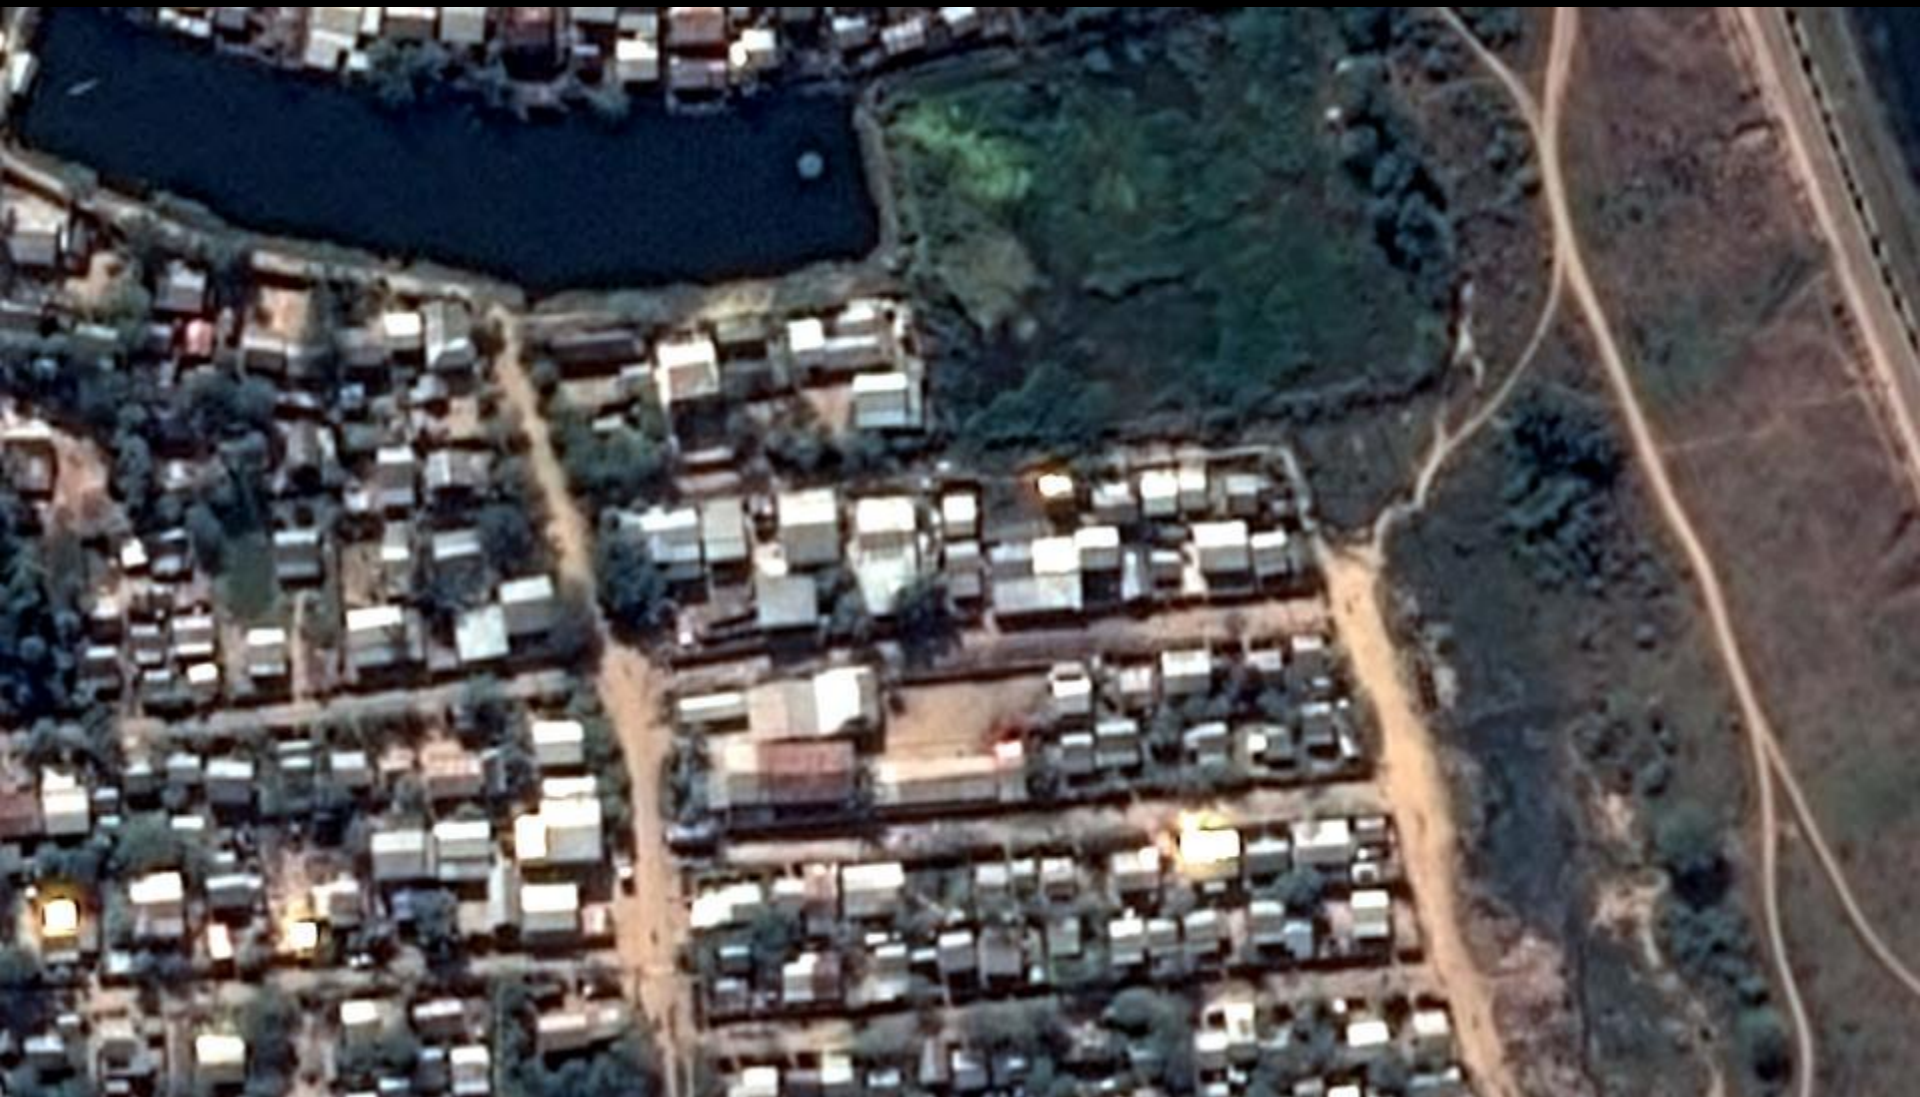
Meiktila (Main Damage Area 3) as on December 13, 2012

(Pre-violence view of third largest concentration of building damages)

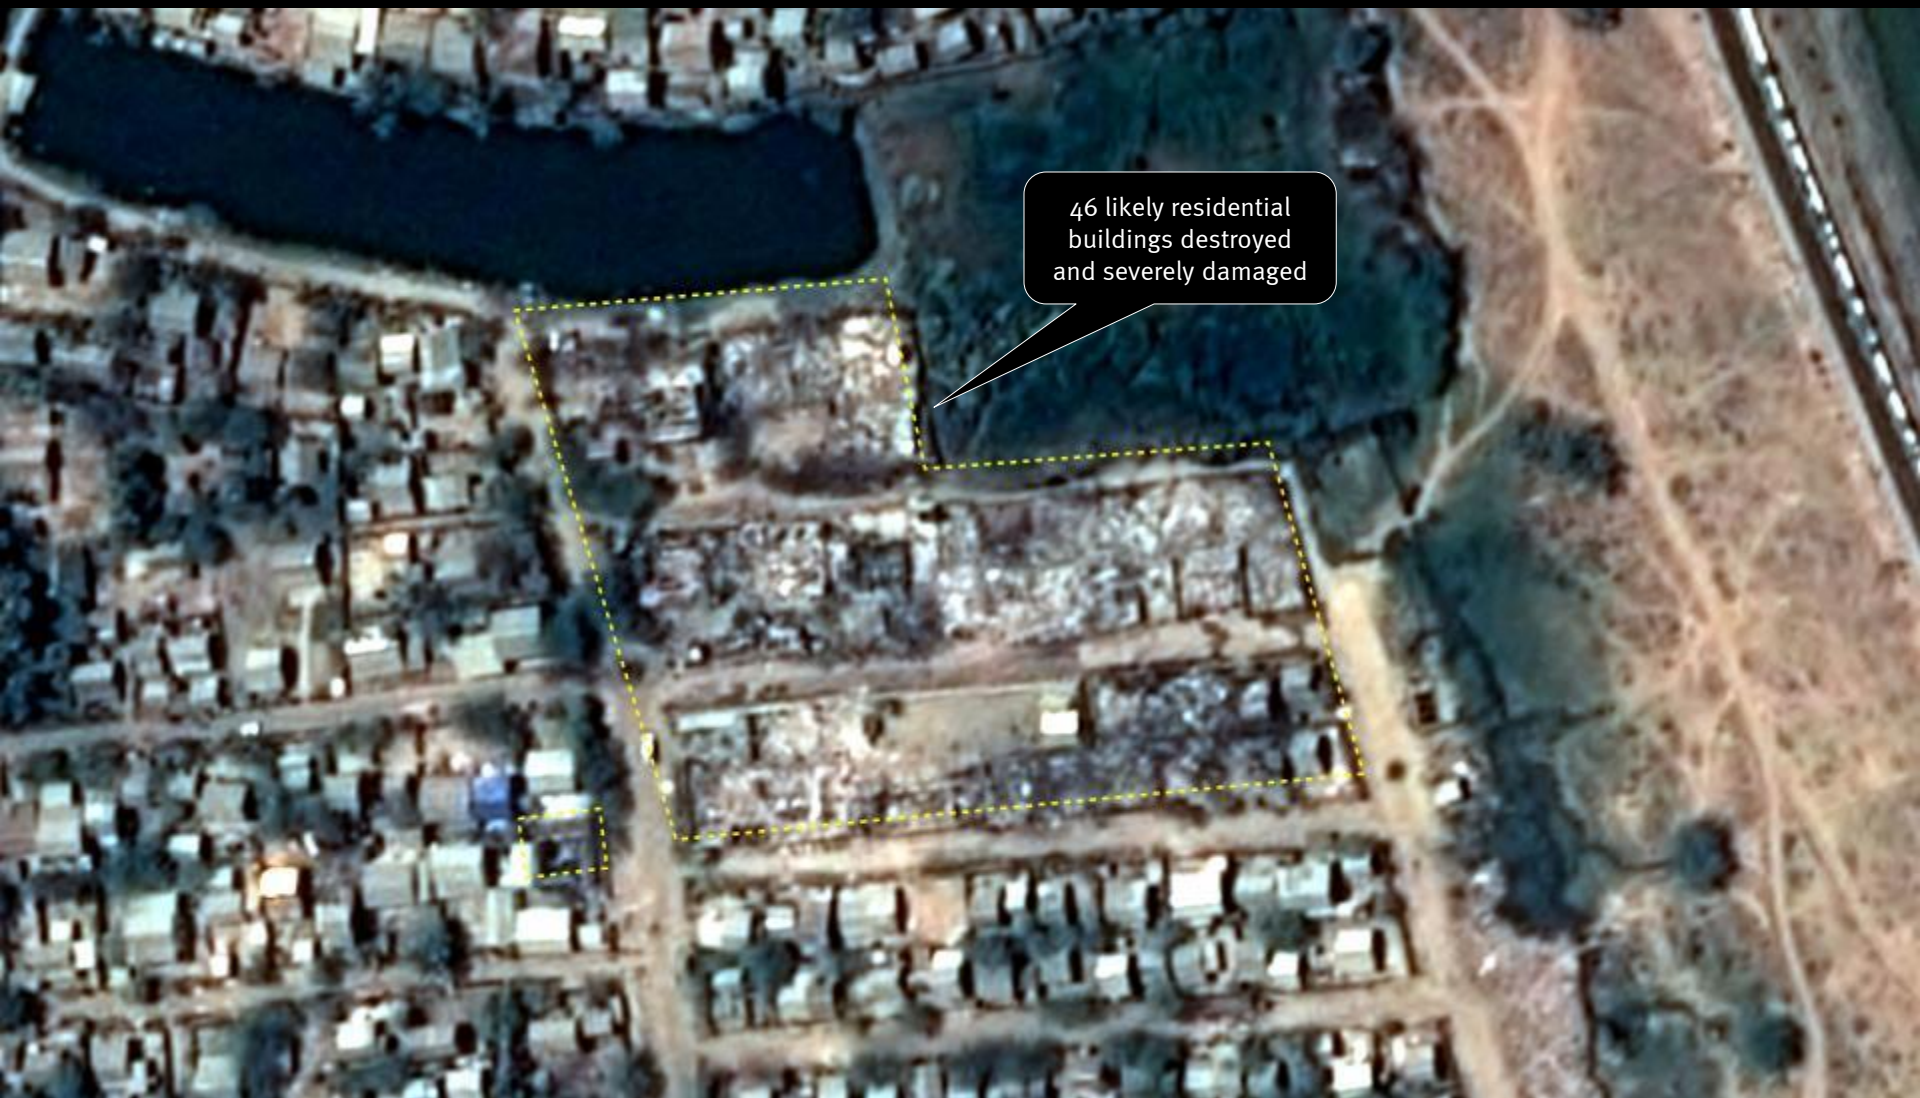
Meiktila (Main Damage Area 3) as on March 26, 2013

(Post-violence view of third largest concentration of building damages)

46 likely residential buildings destroyed and severely damaged

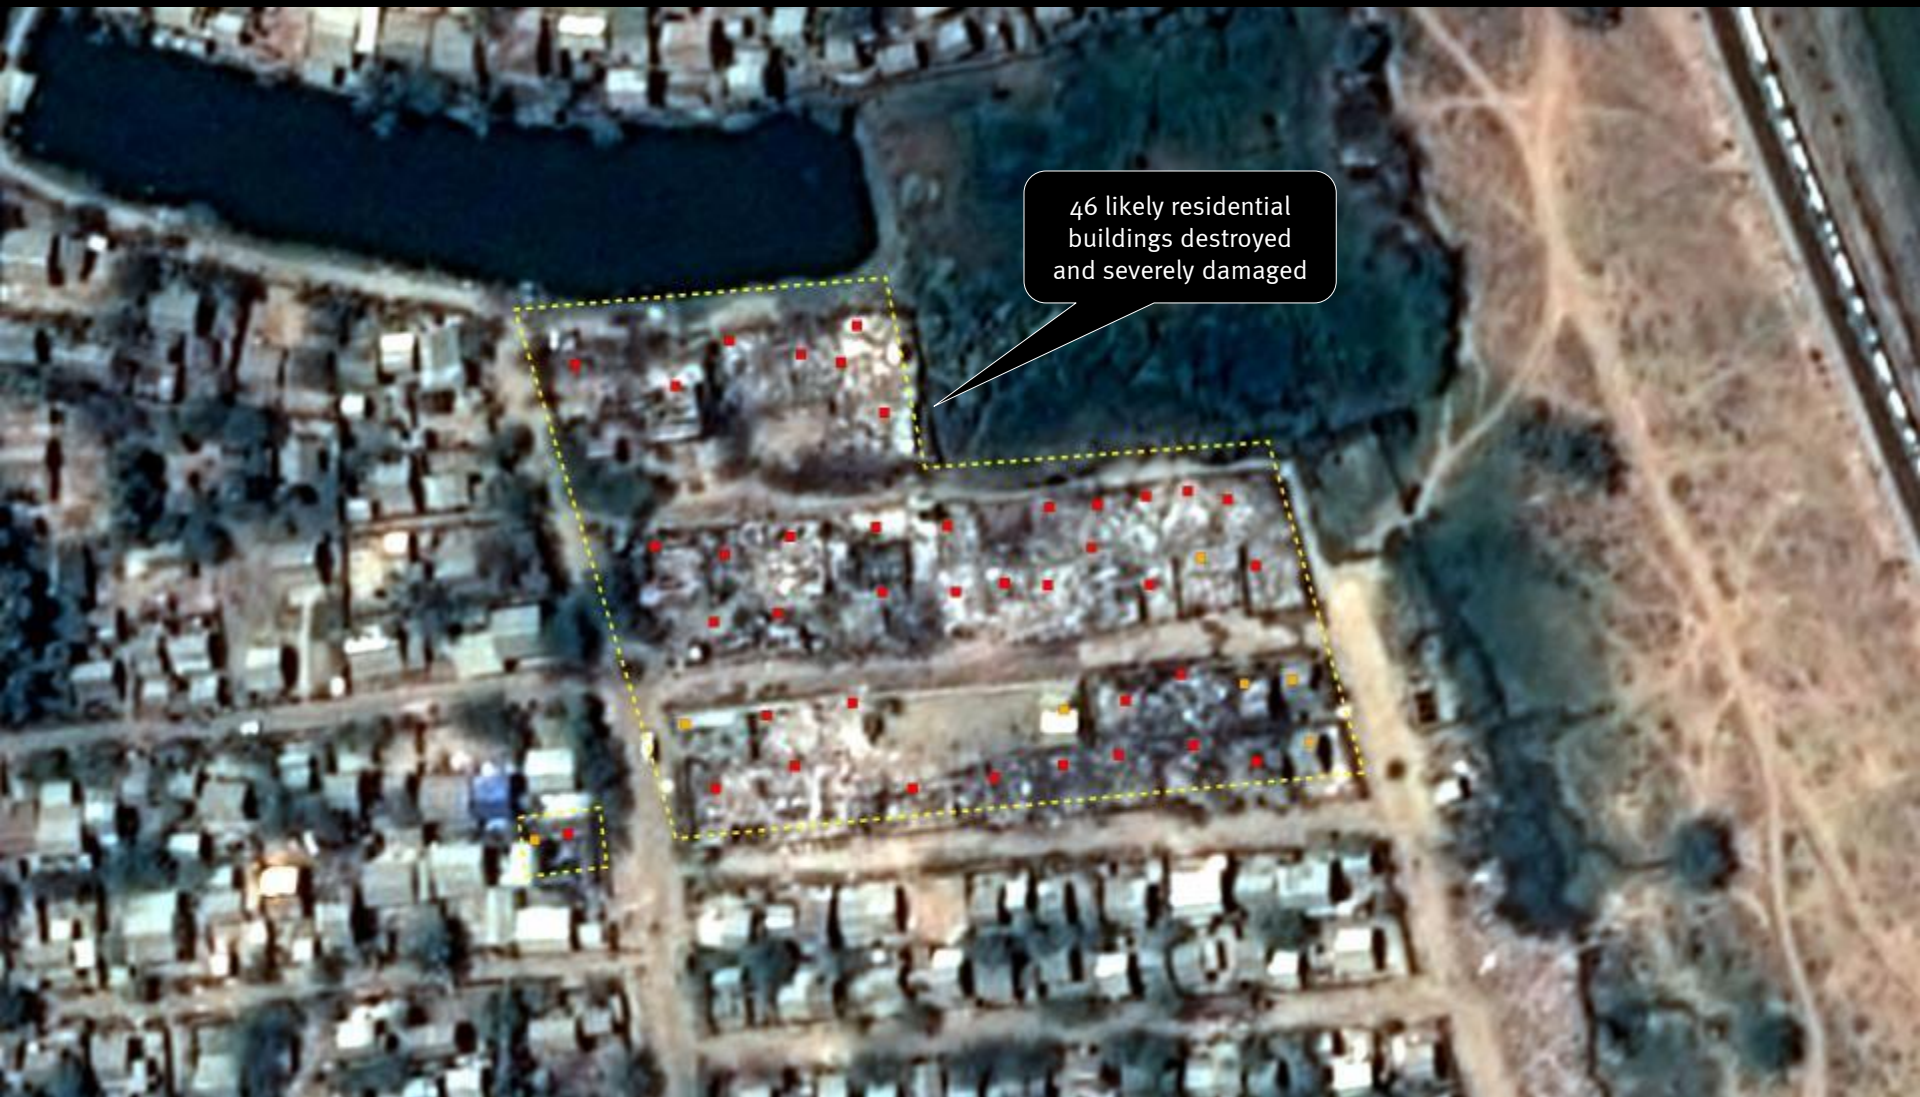
Meiktila (Main Damage Area 3) as on March 26, 2013

(Post-violence view of third largest concentration of building damages – Damages Annotated)

46 likely residential buildings destroyed and severely damaged

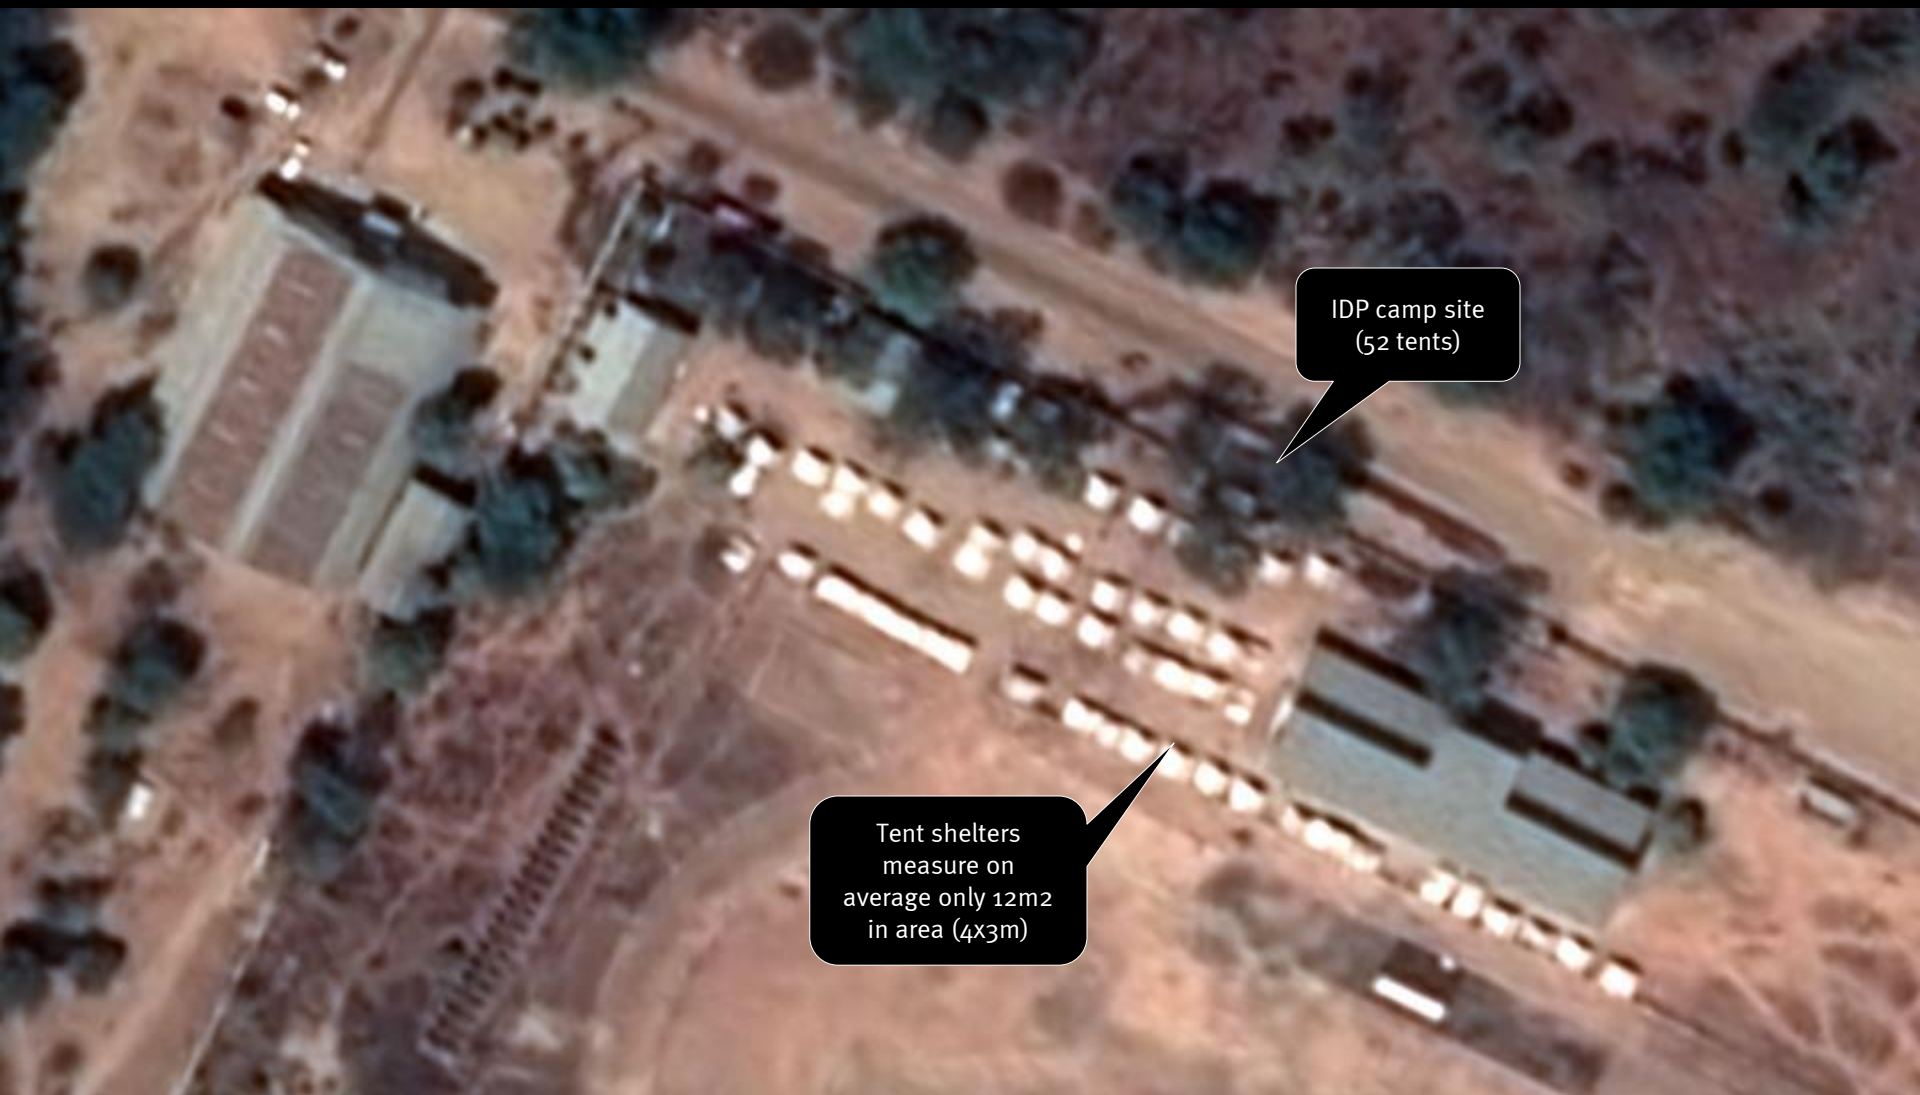
Meiktila (IDP Camp Site) as on March 26, 2013:

(Post-violence view of IDP Camp Site located 750m southeast of the main city market)

IDP camp site
(52 tents)

Tent shelters
measure on
average only 12m²
in area (4x3m)
